Wetlands Research Program Technical Report WRP-RE-17

Proceedings of the National Workshop on Geotextile Tube Applications

by Jack E. Davis, Mary C. Landin

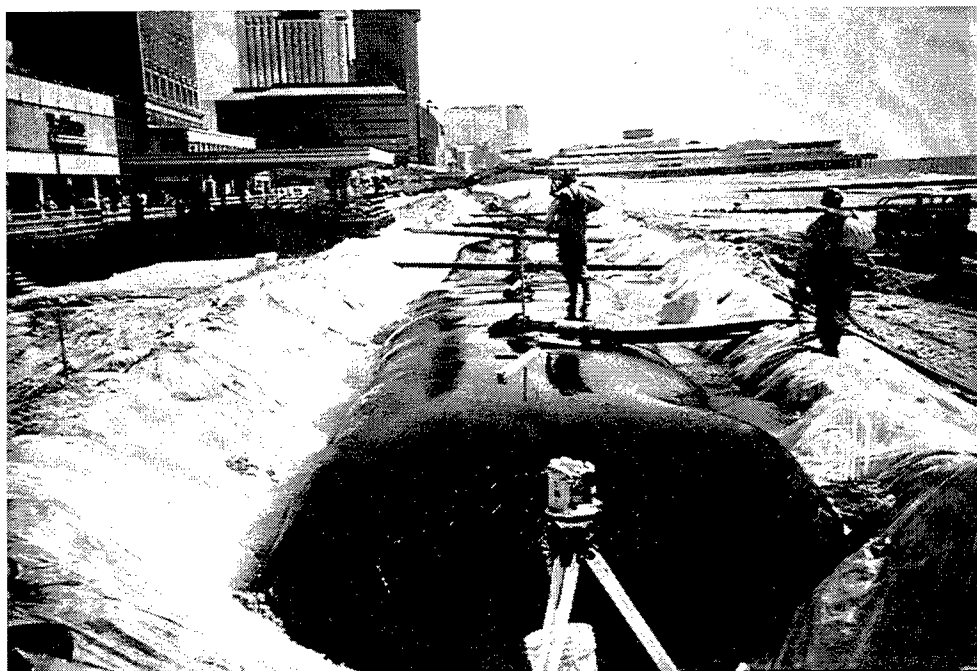
Figure 1. Construction of the geotextile tube in front of the Atlantic City, NJ, boardwalk

Atlantic City, NJ. Geotextile tubes were placed in 1995 in front of the boardwalk along Atlantic City's beach as part of a municipal shore protection project. Apparently, sand is forced beneath the boardwalk during storms, which damages the structure. A trench was excavated along the existing dune, and an impermeable barrier (such as plastic) was placed in the trench. The tube was placed in the trench on top of the impermeable fabric. An induction pump was used to dredge sand off the beach and fill the tubes. The impermeable underliner captured water permeating out of the tube and directed it to an outlet to prevent erosion around the tubes. Figure 1 shows the tube under construction. The tube was then covered over with sand and vegetated, giving the site the appearance of a natural dune. The design was unobtrusive. In the event of a storm, the tube would become exposed and act as shore protection. Hence, the tube is hidden protection, only becoming evident when erosion begins. The project weathered a recent storm in which the tubes were exposed and the boardwalk was protected.

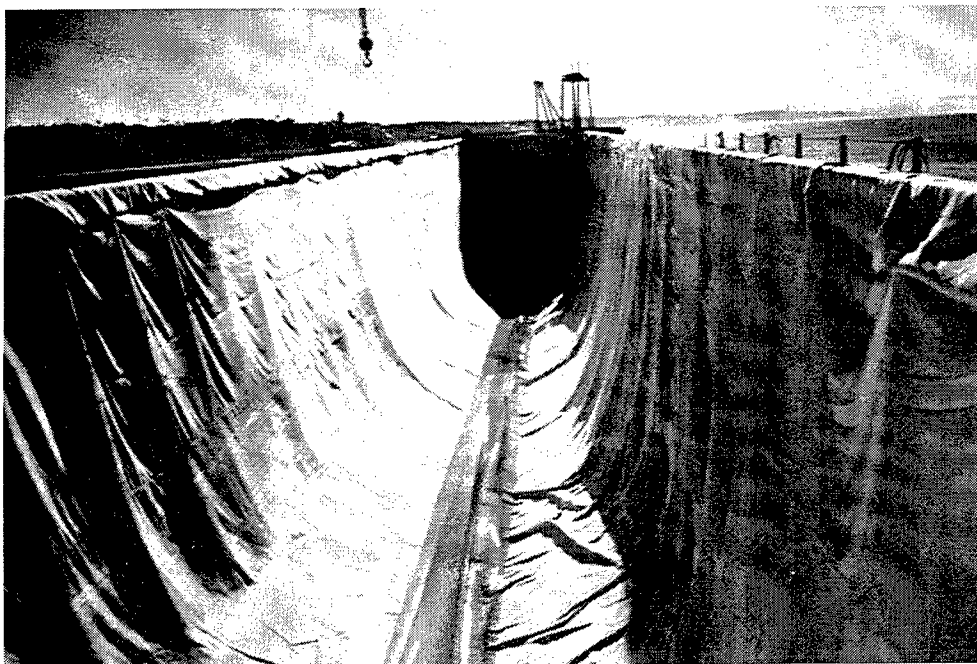
Figure 7. Geotextile liner inside a split-hull scow used in the Marina del Ray contaminated material containerization project

subsequent containers would not lodge during disposal operations. The hopper interior polypropylene woven fabric liner was permanently removed to minimize friction between the geotextile container and the bin bulkheads. It was determined that the fabric type used actually increased friction due to surface roughness. Note also that the bin was inspected to be sure it was free of burrs that might otherwise damage the geotextile fabric. The circumference of each container was increased from 90 to 120 ft to provide more sediment mobility during container release. The extra fabric was accordion folded into the bottom of the bin. The volume of material placed in each container was reduced. The optimal volume was about 1,300 cu yd. The scow was loaded differentially along its length as well, such that one end of the bin was filled 2 ft less than the other. This increased and improved the flow of water into the bin. The seam used to close the container was altered to speed up operations. Originally, a "J" seam (two layers of fabric folded over, total of four fabric layers) was used. But later, a "prayer" seam (two fabric layers) was used. This decreased the total sewing time and decreased the number of malfunctions in the sewing machine at no loss of seam strength to the container system.
